UNRBA Monitoring  
Program  
PFC Meeting  
November 4, 2014

# Update on the Monitoring Program

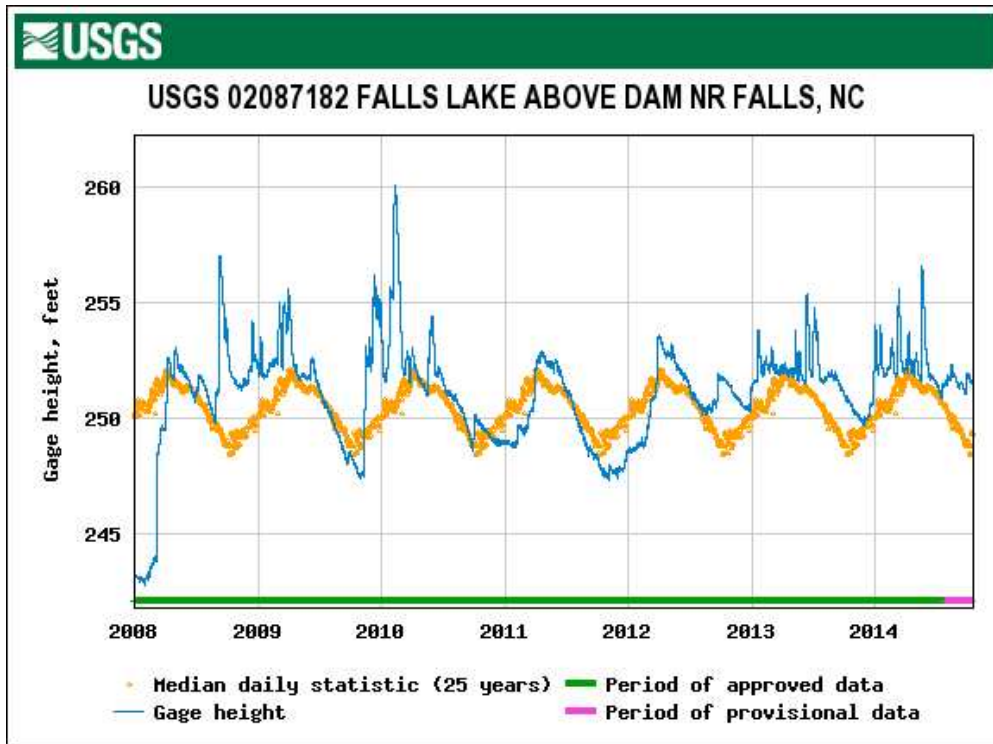
Figure 1: Falls Lake daily water height and median daily value from January 2008 through October 2014

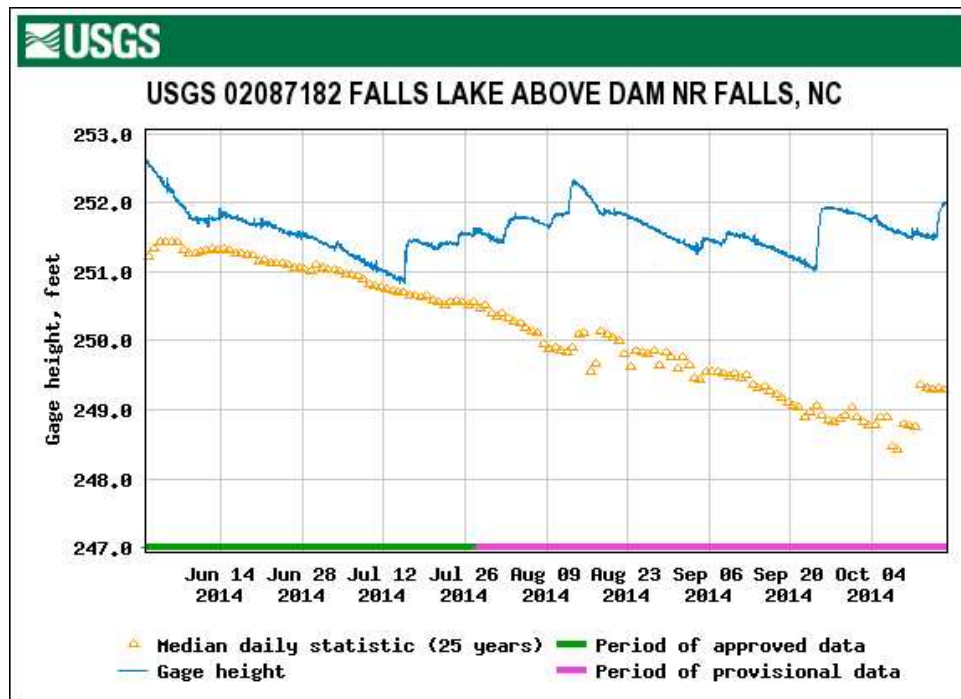
**Figure 1: Falls Lake elevations since June 1, 2014**
